The
LaQUE CENTER
FOR CORROSION TECHNOLOGY, INC.

**SEAWATER CREVICE CORROSION RESISTANCE OF
STAINLESS STEELS COATED WITH
SILANE AND ANTIFOULING PAINT SYSTEMS**

**FINAL REPORT
CONTRACT N00014-01-C-0177**

August 2002

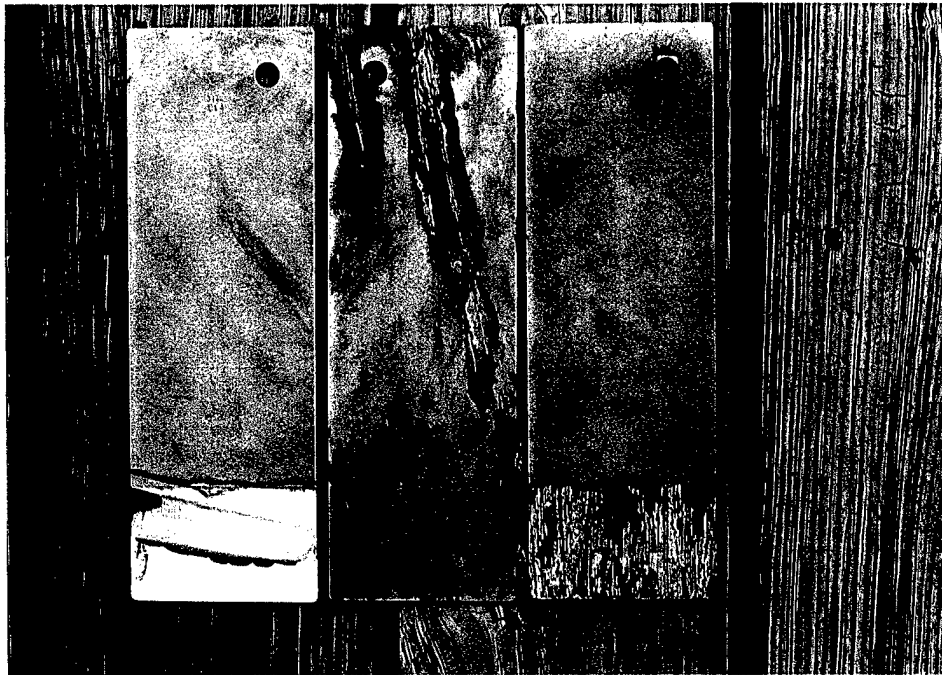
Figure ES-1. Comparative views of S31603 specimens partially coated with (left-right) epoxy, silane alone and silane + ablative-Cu and exposed for nine months.

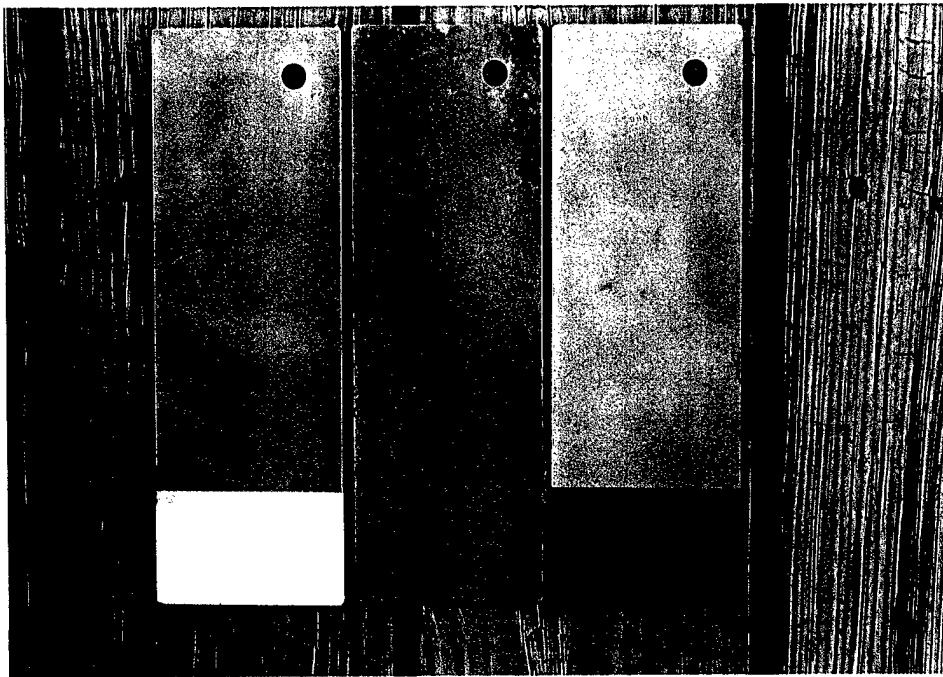
Figure ES-2. Comparative views of N08367 specimens partially coated with (left-right) epoxy, silane alone and silane + ablative-Cu and exposed for nine months.

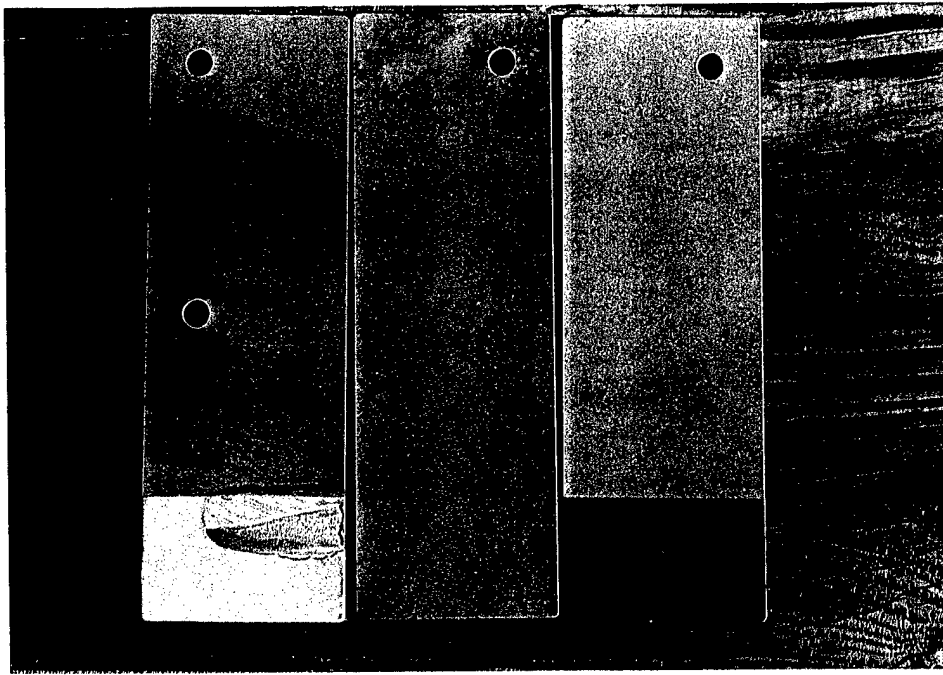
FIGURE 3 – Representative view (left) affected epoxy coated and (center and right) resistant silane and silane + ablative Cu coated N08367 specimens after three months seawater exposure.

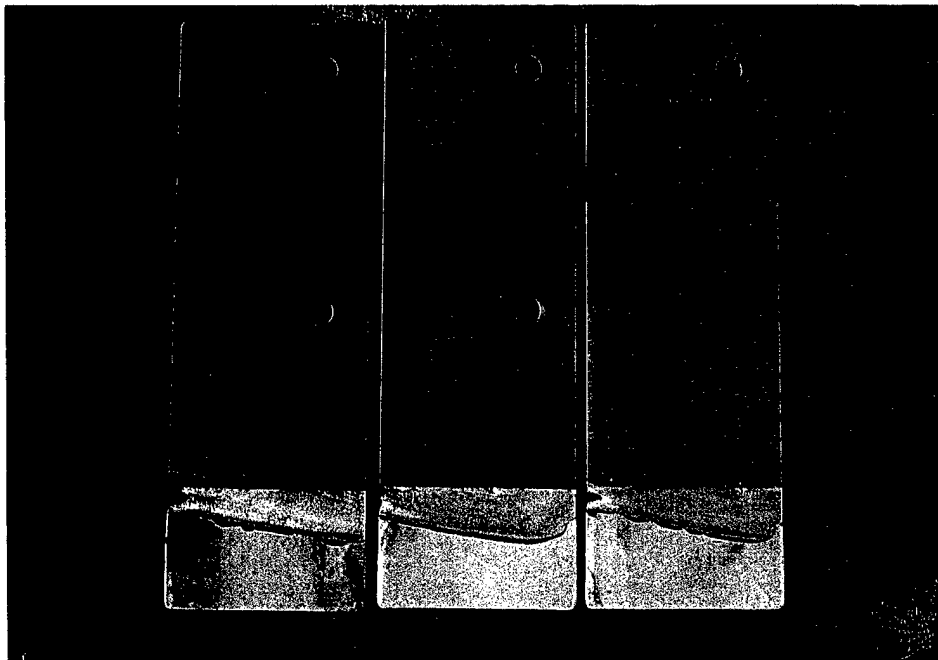
FIGURE 4 – View of partially cleaned S31603 specimens with 20% epoxy coverage showing extensive crevice corrosion and pitting.

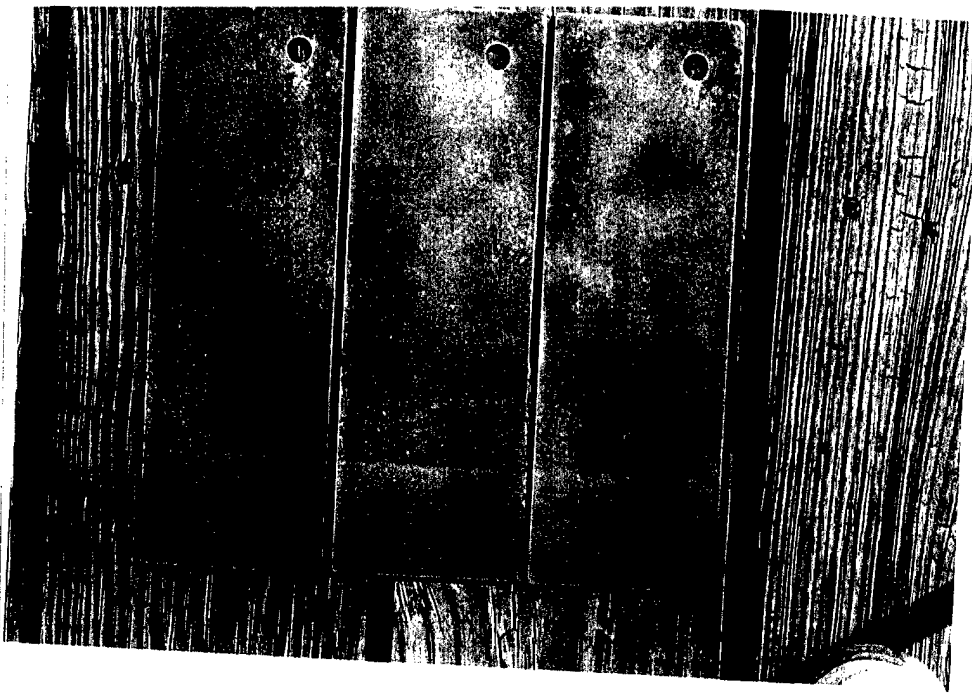
Figure 24.3 2609-04-021-7

In contrast to the above, final inspection of the 18 partially coated N087367 specimens (Figures 24.1 to 25.3) revealed no evidence of corrosion within the areas coated (20% and 80%)
